£100,000 Damage in Hazardous Sheffield Blaze

Sheffield fire-fighters faced extremely hazardous conditions at a fire which, says CFO B. Jones, O.B.E., in a report for Fire, showed that it is a fallacy to say there is "nothing to burn" in the steel manufacturing industries.

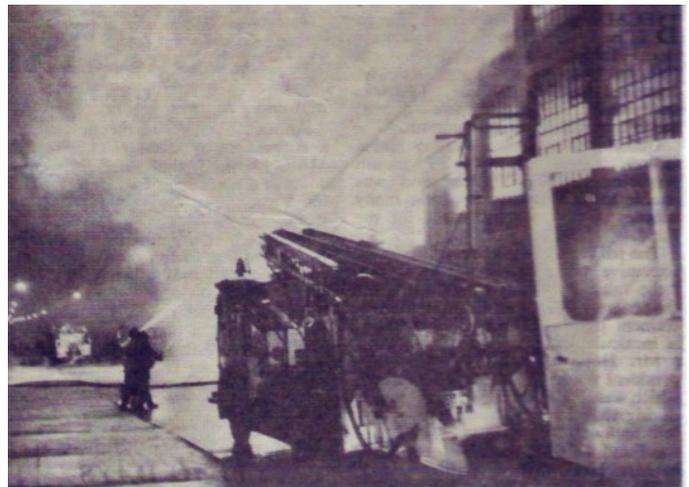
A fireman collects more hose from the appliance as colleagues face the intense radiated heat shortly after the collapse of the roof.

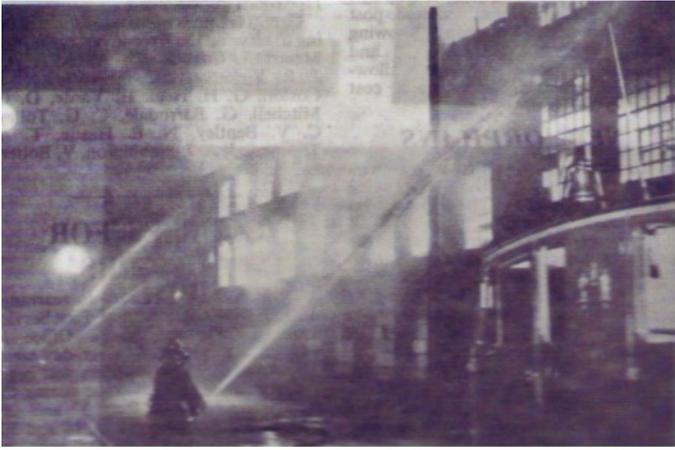
Weakened walls collapse into fire area

The collapsed section was an old part of the building, principally used for the manufacture and testing of steel wire and the incident again showed that it is a fallacy to say that there is “nothing to burn” in the steel manufacturing industries.

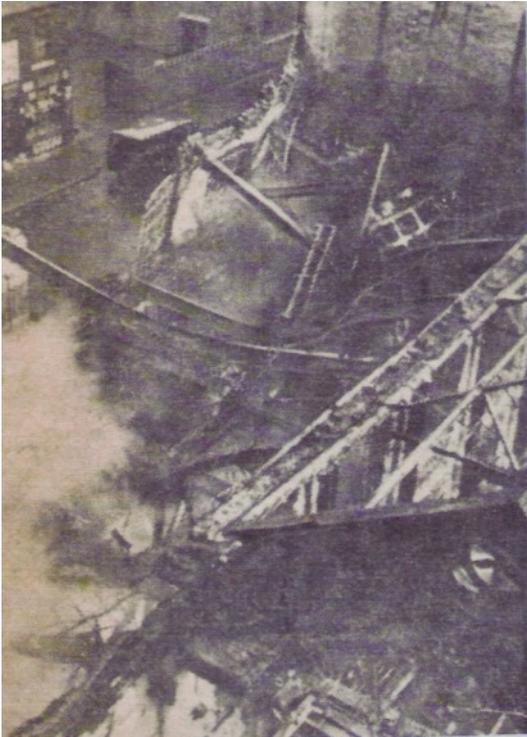
Left: The collapsed roof and buckled walls bear tragic witness to the ferocity of the fire in the wire drawing department - the worst blaze in the city since the war.
